PRESTRESSED CONCRETE TEE BEAMS WITH  
LARGE WEB OPENINGS

A THESIS

DEPARTMENT OF CIVIL ENGINEERING  
EDMONTON, ALBERTA

FALL, 1970

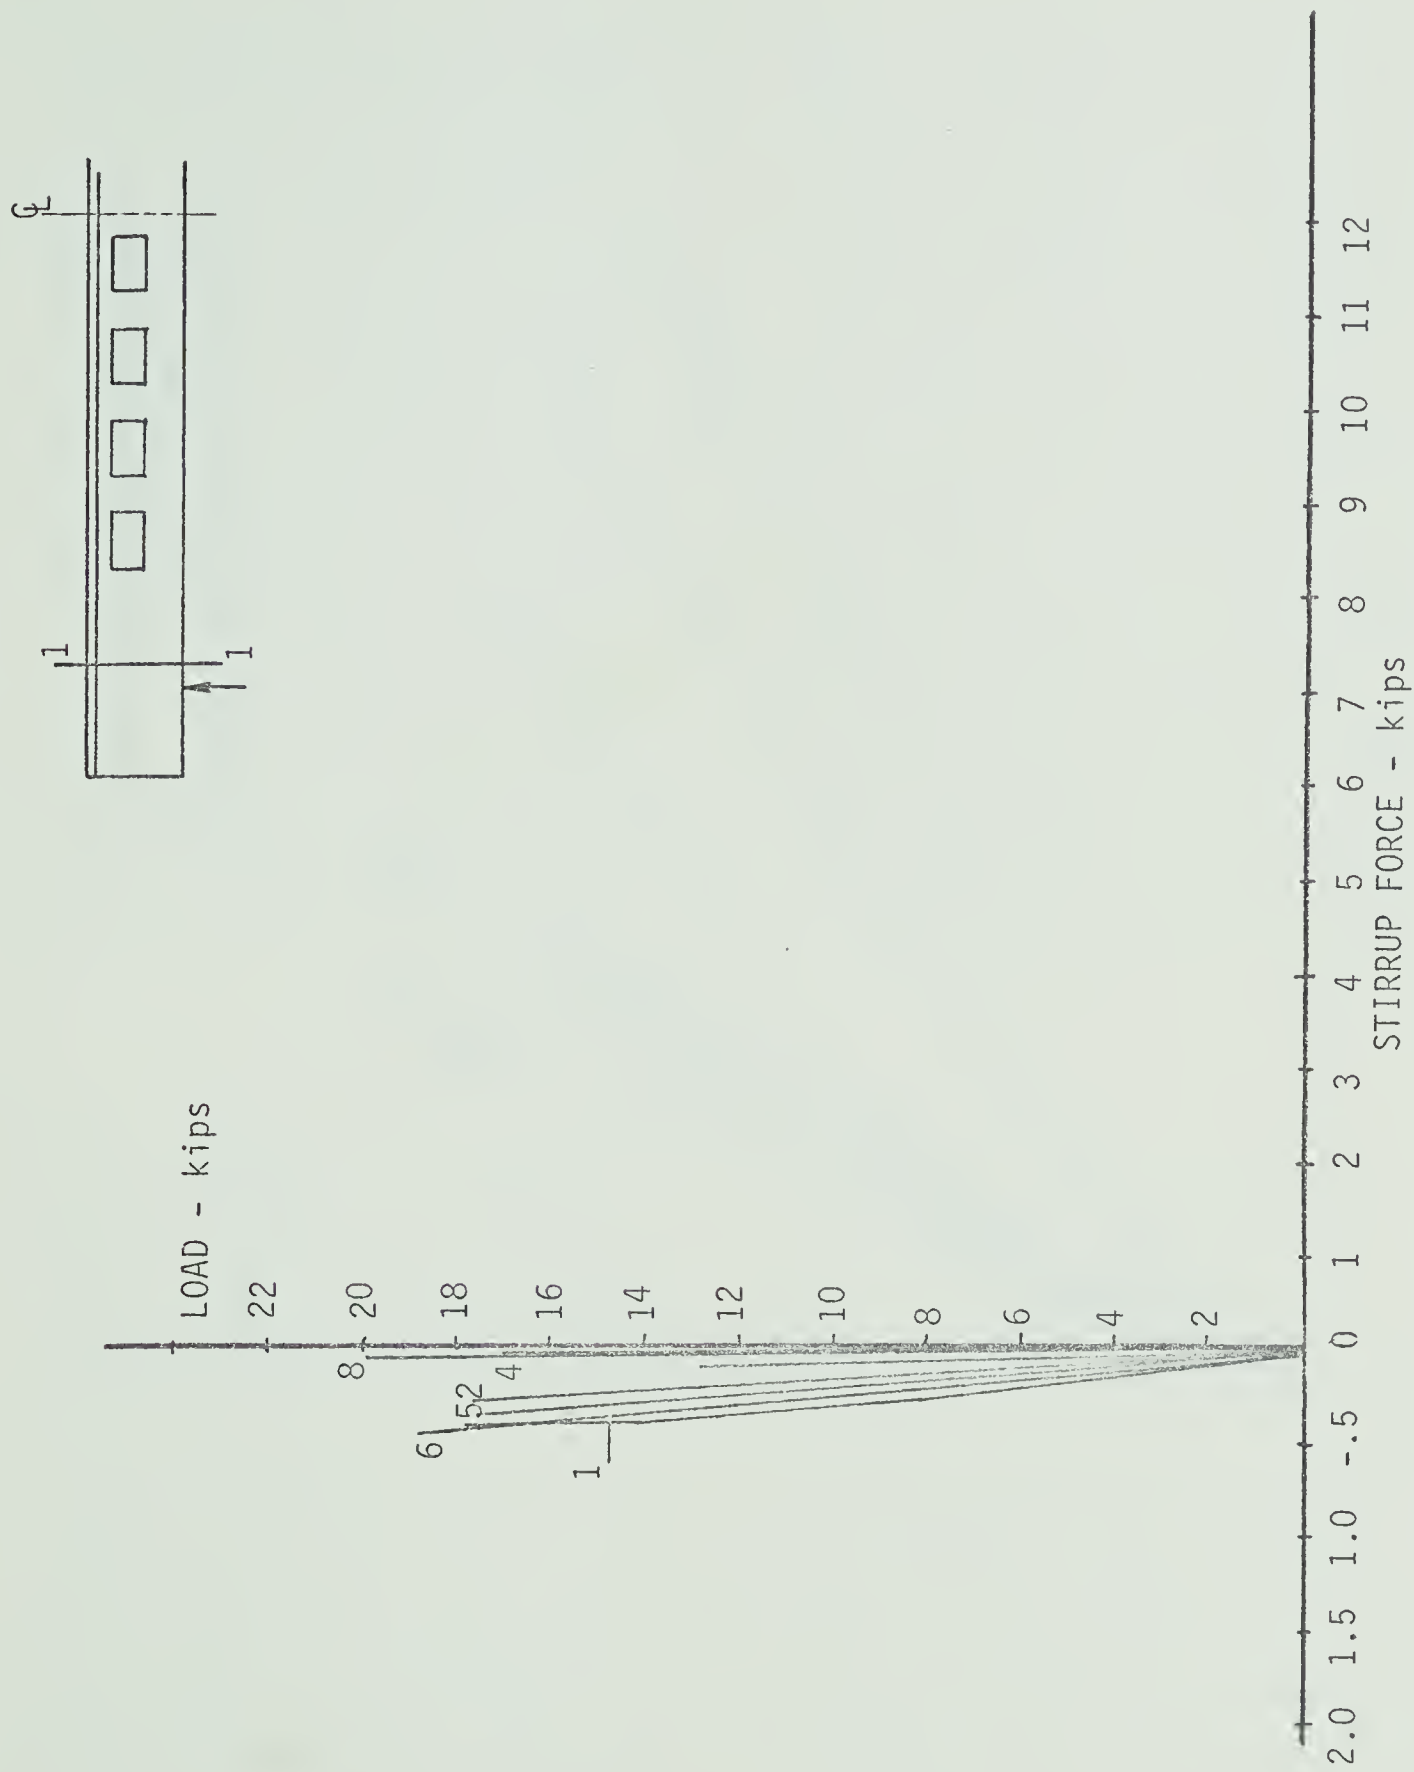
FIGURE 4.4 (a) LOAD-STIRRUP FORCE RELATIONSHIP AT SHEAR SECTION 1

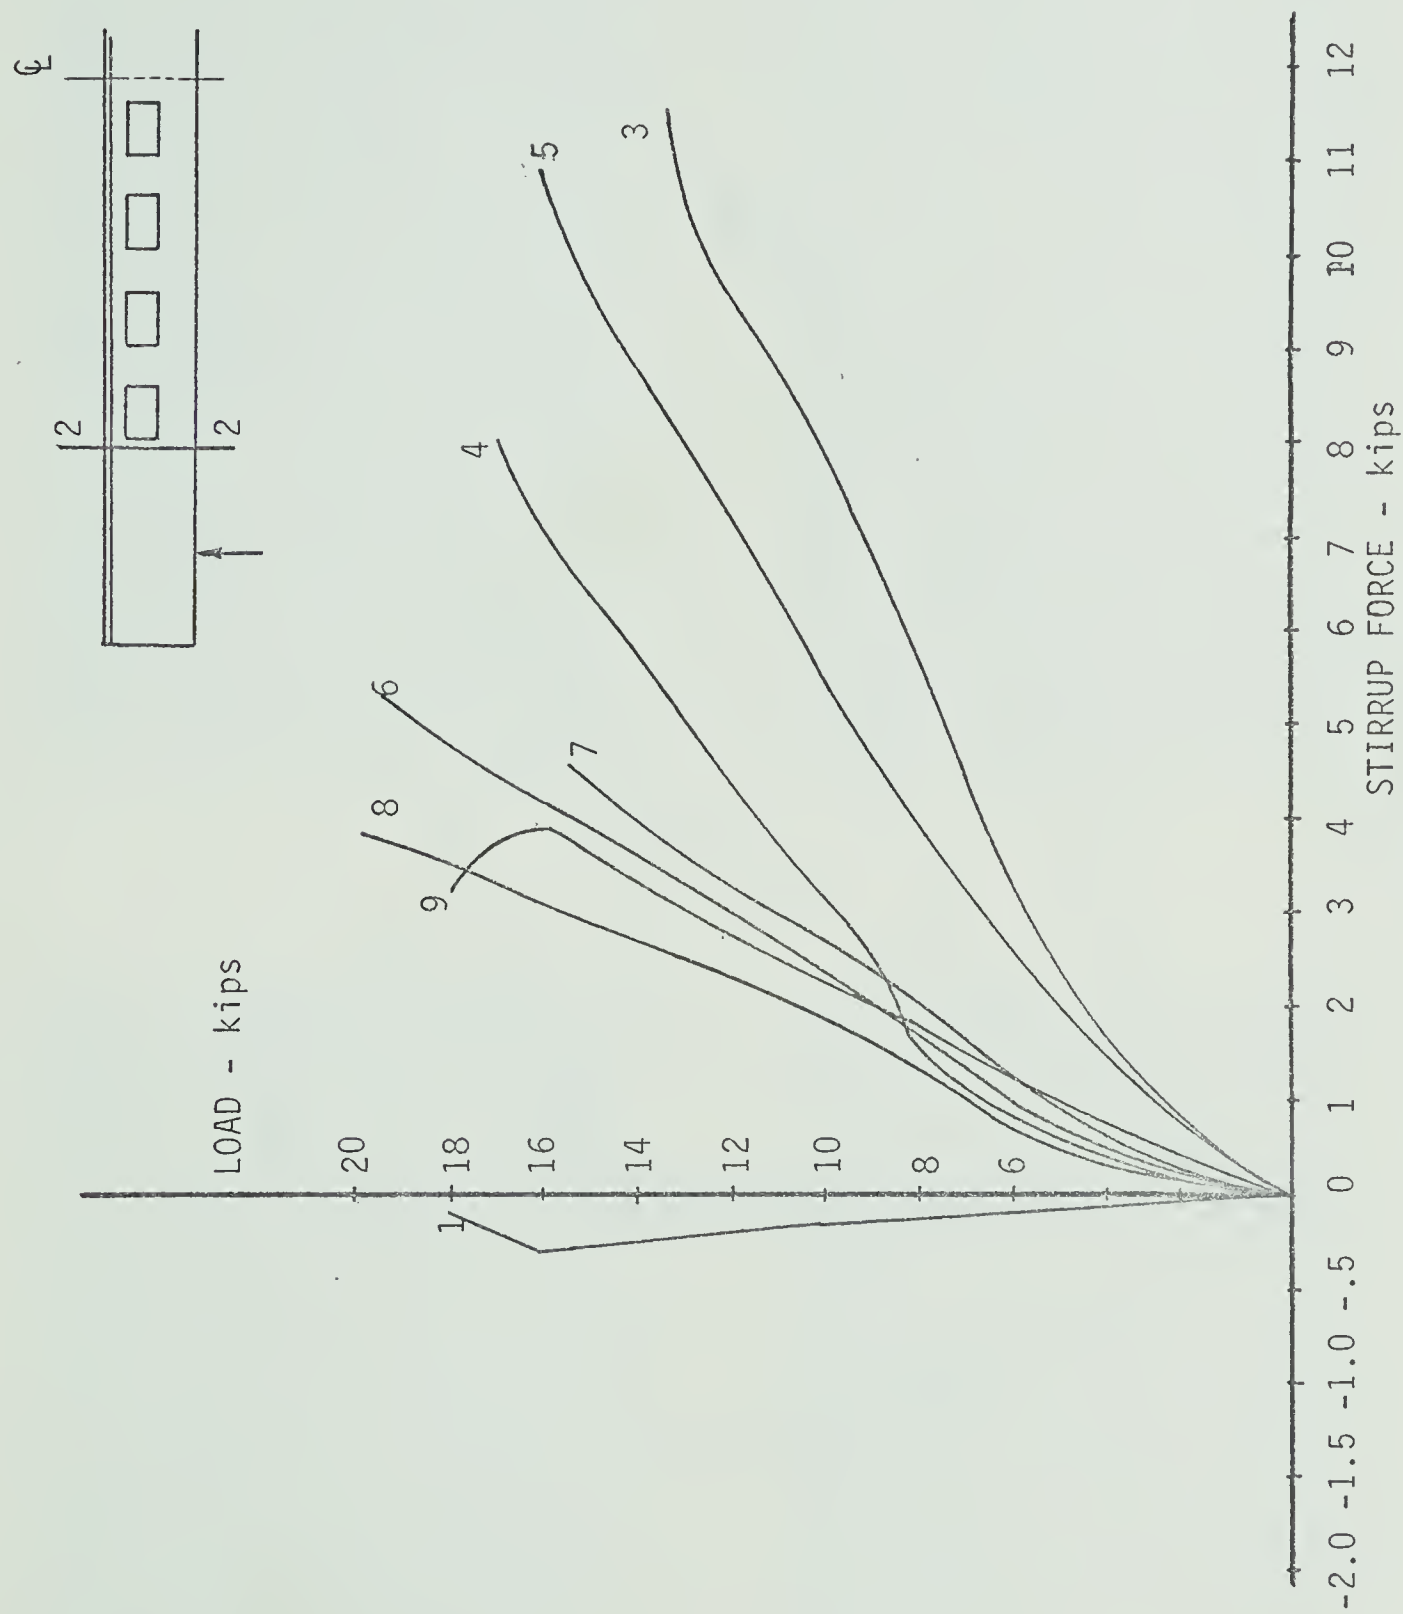
FIGURE 4.4 (b) LOAD-STIRRUP FORCE RELATIONSHIP AT SHEAR SECTION 2

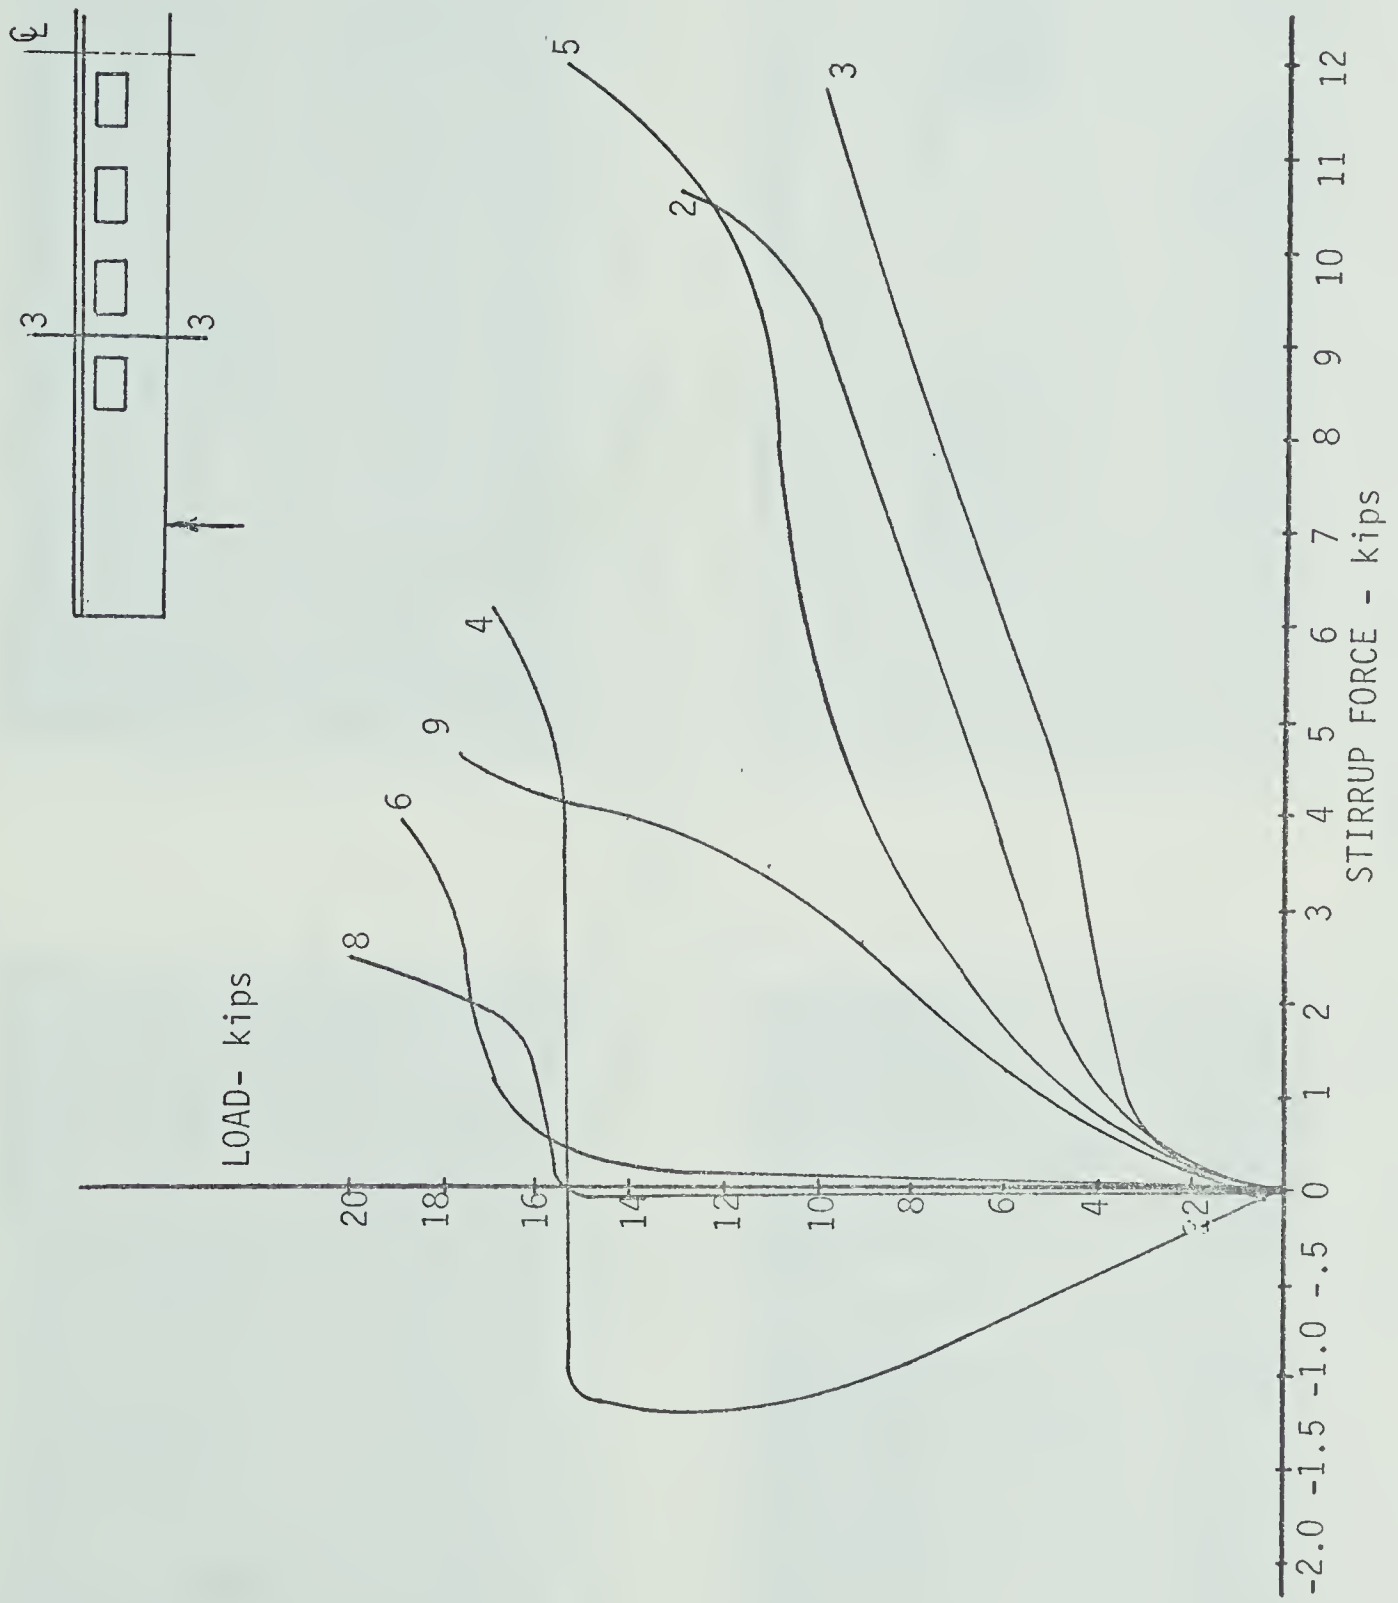
FIGURE 4.4 (c) LOAD-STIRRUP FORCE RELATIONSHIP AT SHEAR SECTION 3

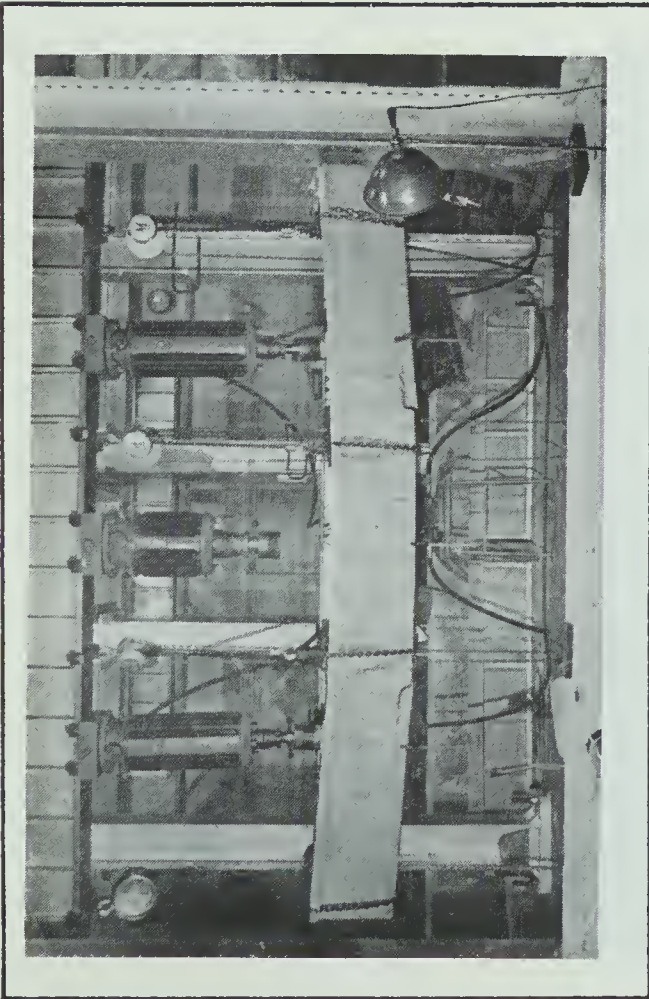
FIGURE 4.5 BEAM #1 CRACKING AND FAILURE PATTERNS

and from the cracking patterns, as shown in Fig. 4.5 and the load-deflection curves, it is very reasonable to say that this beam behaved as a typical underreinforced prestressed Tee beam. Flexural cracks were first observed at a load of 9.5 kips per jack and progressed rapidly to failure. Since load was applied by two symmetrically placed jacks, the flexural cracks occurred at regular intervals within the pure moment span. The cracks opened considerably especially at sections located approximately one foot in from the load points. At these sections, a concentration of stress occurred as the supplementary longitudinal reinforcement terminated here. The reason for having this projection of reinforcement into the pure moment span was to develop sufficient bond in this reinforcement to enable measurement of the strain by strain gages located under the point of load.

Failure of this beam resulted from the visible fracture of one of the prestressing strands. This strand snapped at approximately one foot in from the load point, that is, at the point of concentration of stress at the projected end of the supplementary longitudinal reinforcement. The total vertical deflection at centerline at failure was in excess of 11 in. and after unloading, the beam was permanently deflected by approximately 7 in. at the centerline.

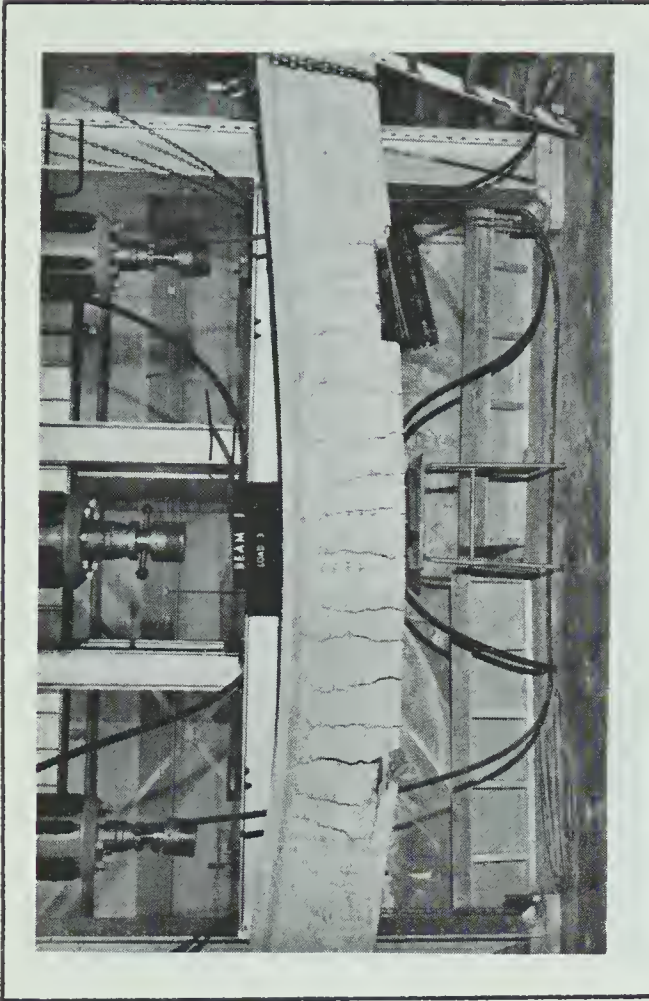
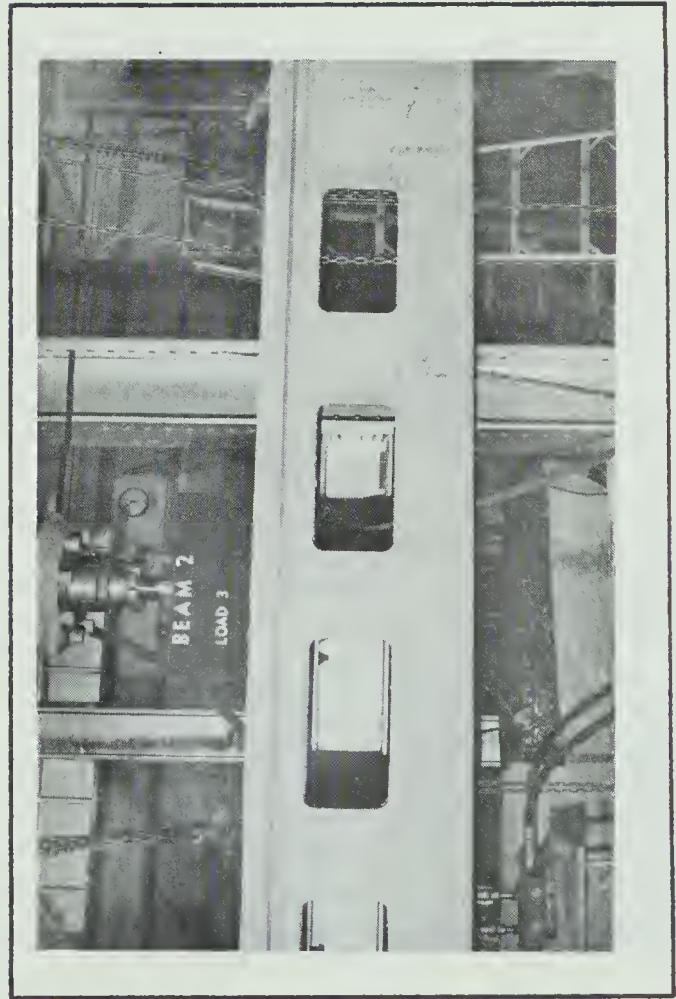
FIGURE 4.6 BEAM #2 CRACKING AND FAILURE PATTERNS

Beam #2 was a direct equivalent of the control beam as the parameters used were identical; the only difference is that beam #2 had large openings, hence the stirrups had to be concentrated in the posts. This "bunching" up of the reinforcement together with the presence of the openings led to high diagonal stress concentrations in the concrete in the lower webs and flanges of the first two holes and in the post adjacent to these two openings. Consequently, the beam failed in shear through severe cracking of the lower webs, flanges and post at a load of 13.5 kips per jack. As indicated from the load-deflection curve, the strain distribution diagrams and the moment-strain diagram, beam #2 behaved similarly to beam #1 up to the failure load; the only difference in this range was that the total average deflections of beam #2 were close to being twice those of the control beam. This verifies Nassers'<sup>3</sup> observations. It should be noted at this time that the load which caused shear failure in this beam has the same value as that predicted by the ACI code(1963)<sup>4</sup> to cause flexural failure.

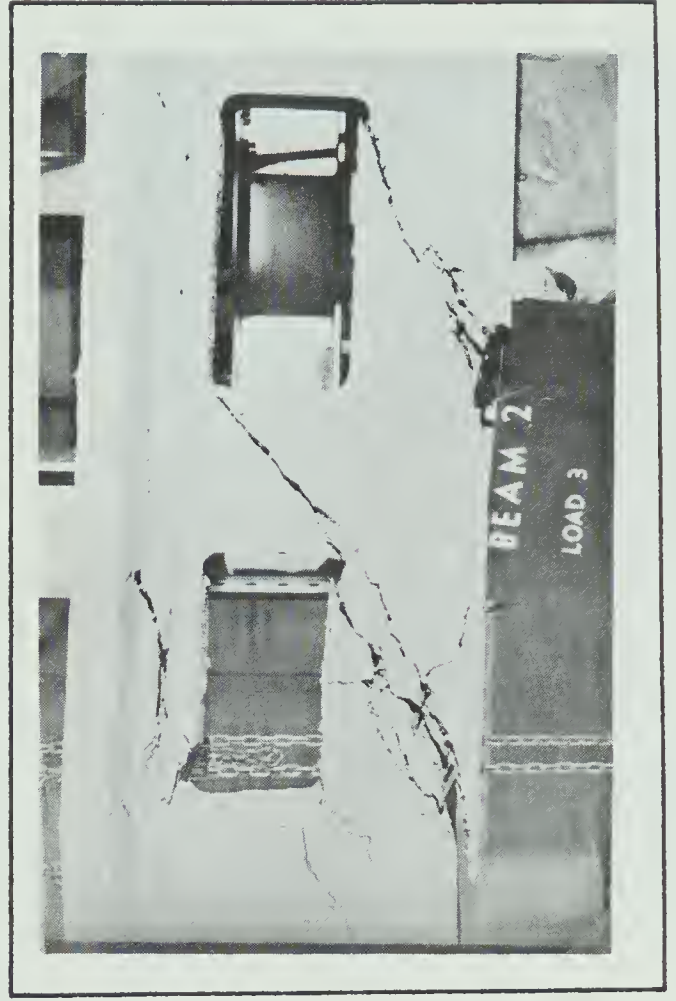
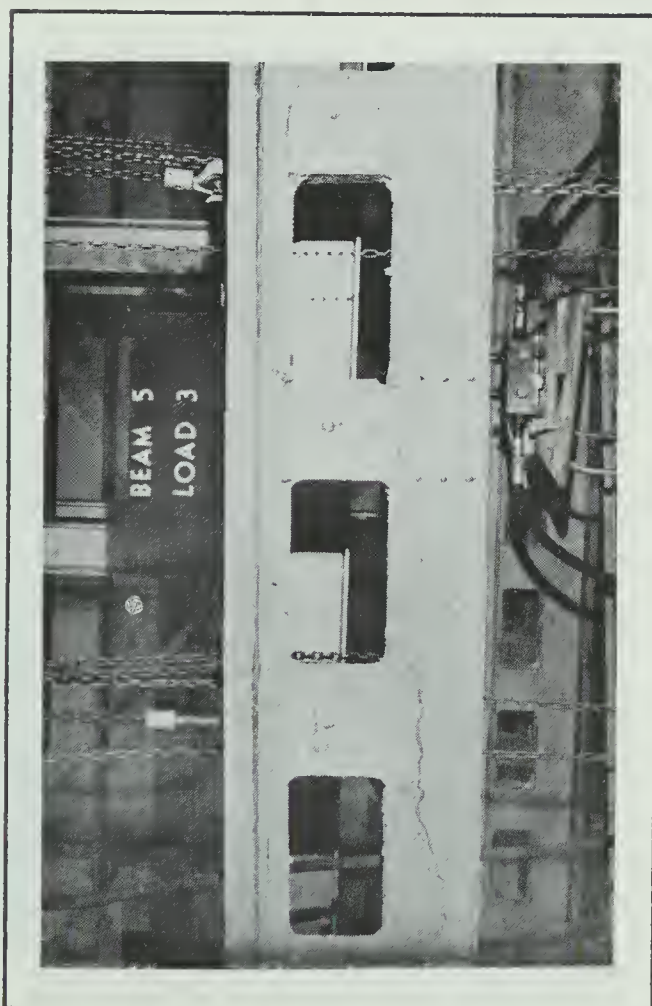
FIGURE 4.7 BEAM #5 CRACKING AND FAILURE PATTERNS

For beam #5, the addition of the extra stirrup in the posts contributed significantly to an increase in its shear capacity which was greater, by 3.0 kips, than that for beam #2. Furthermore, the extra stirrups caused failure to be confined through the lower web and flange of only one hole in contrast to the failure of beam #2 where two holes were affected. This is illustrated in the photographic plates of Chapter IV, in Figs. 4.6 and 4.7. The extra stirrup was also successful in resisting the diagonal tensile forces in the posts, as failure cracks were not present in these posts.

Further phenomenal behaviour was observed at failure. The posts in the pure moment span were sheared at the top and bottom of the openings. Since these posts contained no reinforcement, it is to be expected that they had little transverse shear resistance. The transverse shear resulted most likely from a sudden release of energy. This release occurred as a result of shear failure through the web and flange which caused the energy stored in the prestressing cables to be transferred when the cables became slack at the location of failure, thus causing differential shear between the flange and the lower web.

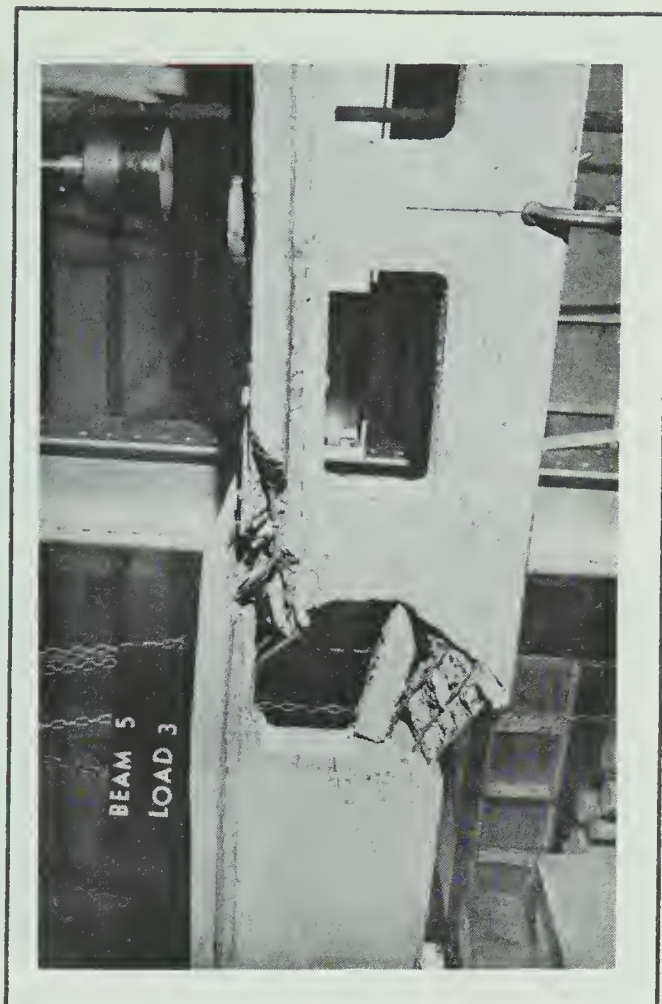
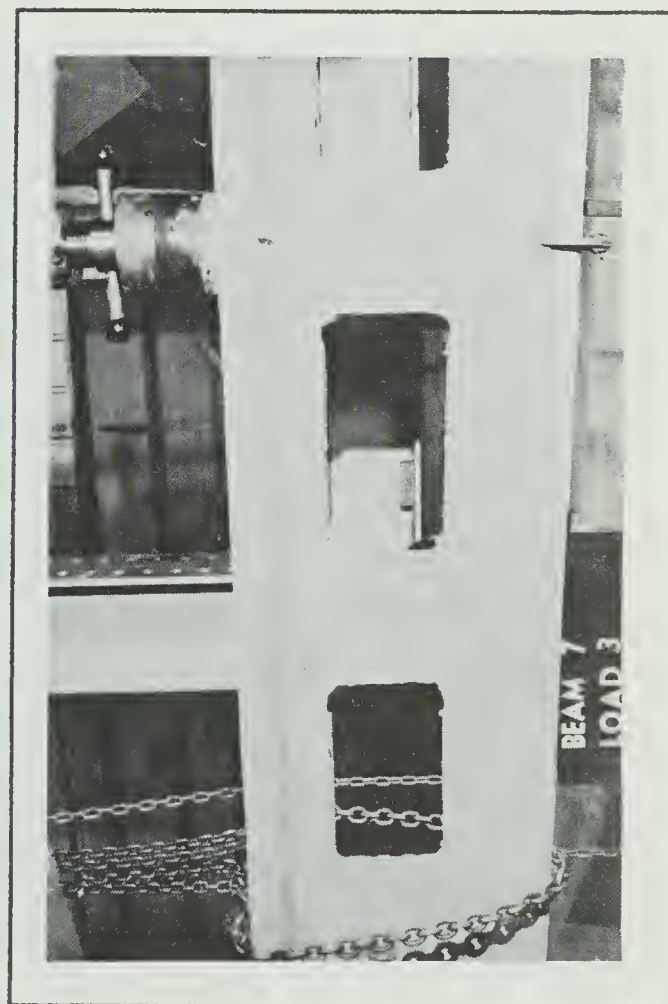
FIGURE 4.8 BEAM #7 CRACKING AND FAILURE PATTERNS

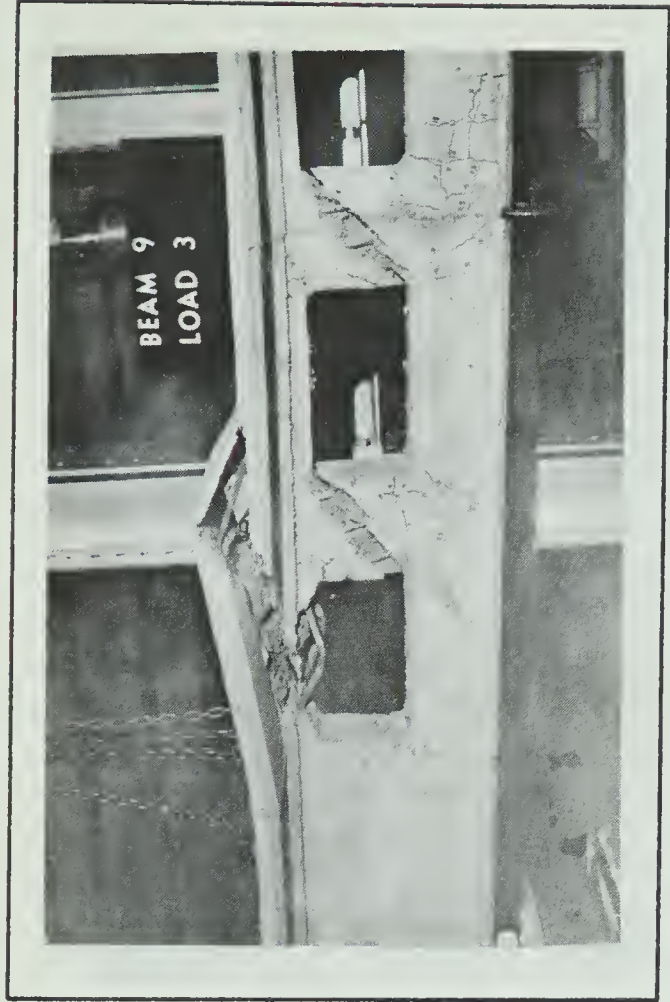
FIGURE 4.9 BEAM #9 CRACKING AND FAILURE PATTERNS

The strain distribution diagrams for beam #9 show that the strain progression at centerline was very much like that of the other beams in this group; the usual strain disruptions near the edges of the openings were apparent also from the cracking as some of the flexural cracking was initiated just below the openings and worked down toward the bottom fibers.

tained for approximately three minutes before failure occurred. Failure was the result of the shear of the two posts located in the north shear span and was quite sudden. At the same time, the center posts were sheared off at the top and bottom, as in beam #5. A large longitudinal crack was also observed at the level of the prestressed reinforcement, at centerline, and this crack spanned approximately four feet. Since complete collapse had not occurred, the beam was subjected to slightly more deflection which caused buckling up of the flange above the first opening. No major shear cracking was observed in the lower webs.

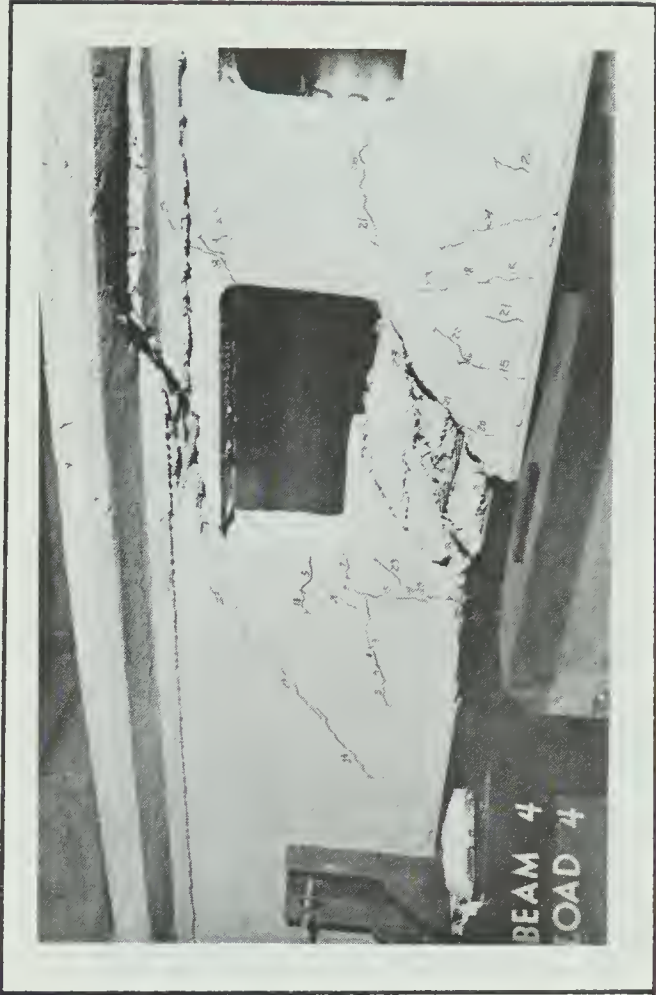
FIGURE 4.10 BEAM #4 CRACKING AND FAILURE PATTERNS

Beam #4 was the first in this series, and was reinforced with two stirrups per post or equivalent spacing at 12 in., and #3 supplementary longitudinal reinforcement, as shown in Fig. 3.4. Being subjected to large shear and small moment, the beam was stiffer than those of load group 3, as shown in Fig. 4.1 (b). Centerline strain distribution linearity is quite apparent for this beam in Fig. 4.2 (b); the strains are linear up to the penultimate load. This was to be expected as the flexural stresses caused by this load of 16.5 kips at this load position were much smaller than those caused by a 13.0 kip load at position 3. Further ultimate behaviour of this beam exemplified Lorentsen's<sup>2</sup> theory that holes in beams should be placed away from shear regions. This beam had a minimum amount of web opening in the shear span, as only one hole was located beyond the pure moment span; consequently, higher shear capacity was attained. It is then to be expected that if no web openings were present in the shear spans, in the beams of group 3 and 4, then flexural and not shear would be the ultimate failure criterion. Figures 4.4 (b) and (c) illustrate this in a trend that indicates that the stirrup force at shear sections 2 and 3 lessens by approximately 2.5 kips or more for each hole removed from the shear span subjected to the same load.

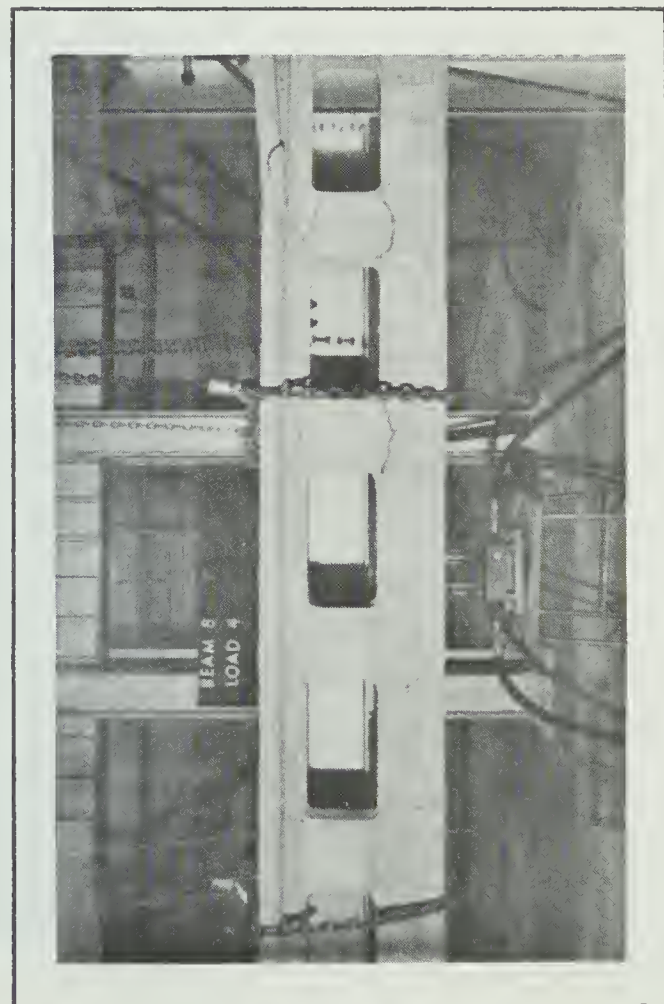
FIGURE 4.12 BEAM #8 CRACKING AND FAILURE PATTERNS

Beam #8 is the last in this series under load position 4 and did not behave much differently than beam #6. The load-deflection diagram for beam #8 indicated a very slight difference in behaviour compared to that of beam #6. Beam #8 did however have a slightly higher shear capacity; 0.5 kip higher. This extra capacity could be attributed to the extra supplementary reinforcement used; #4 bars as compared to #3 bars in beam #6. This gain in strength is so small however, that it could also have been caused by material quality, or by small variations in the placing of the steel.

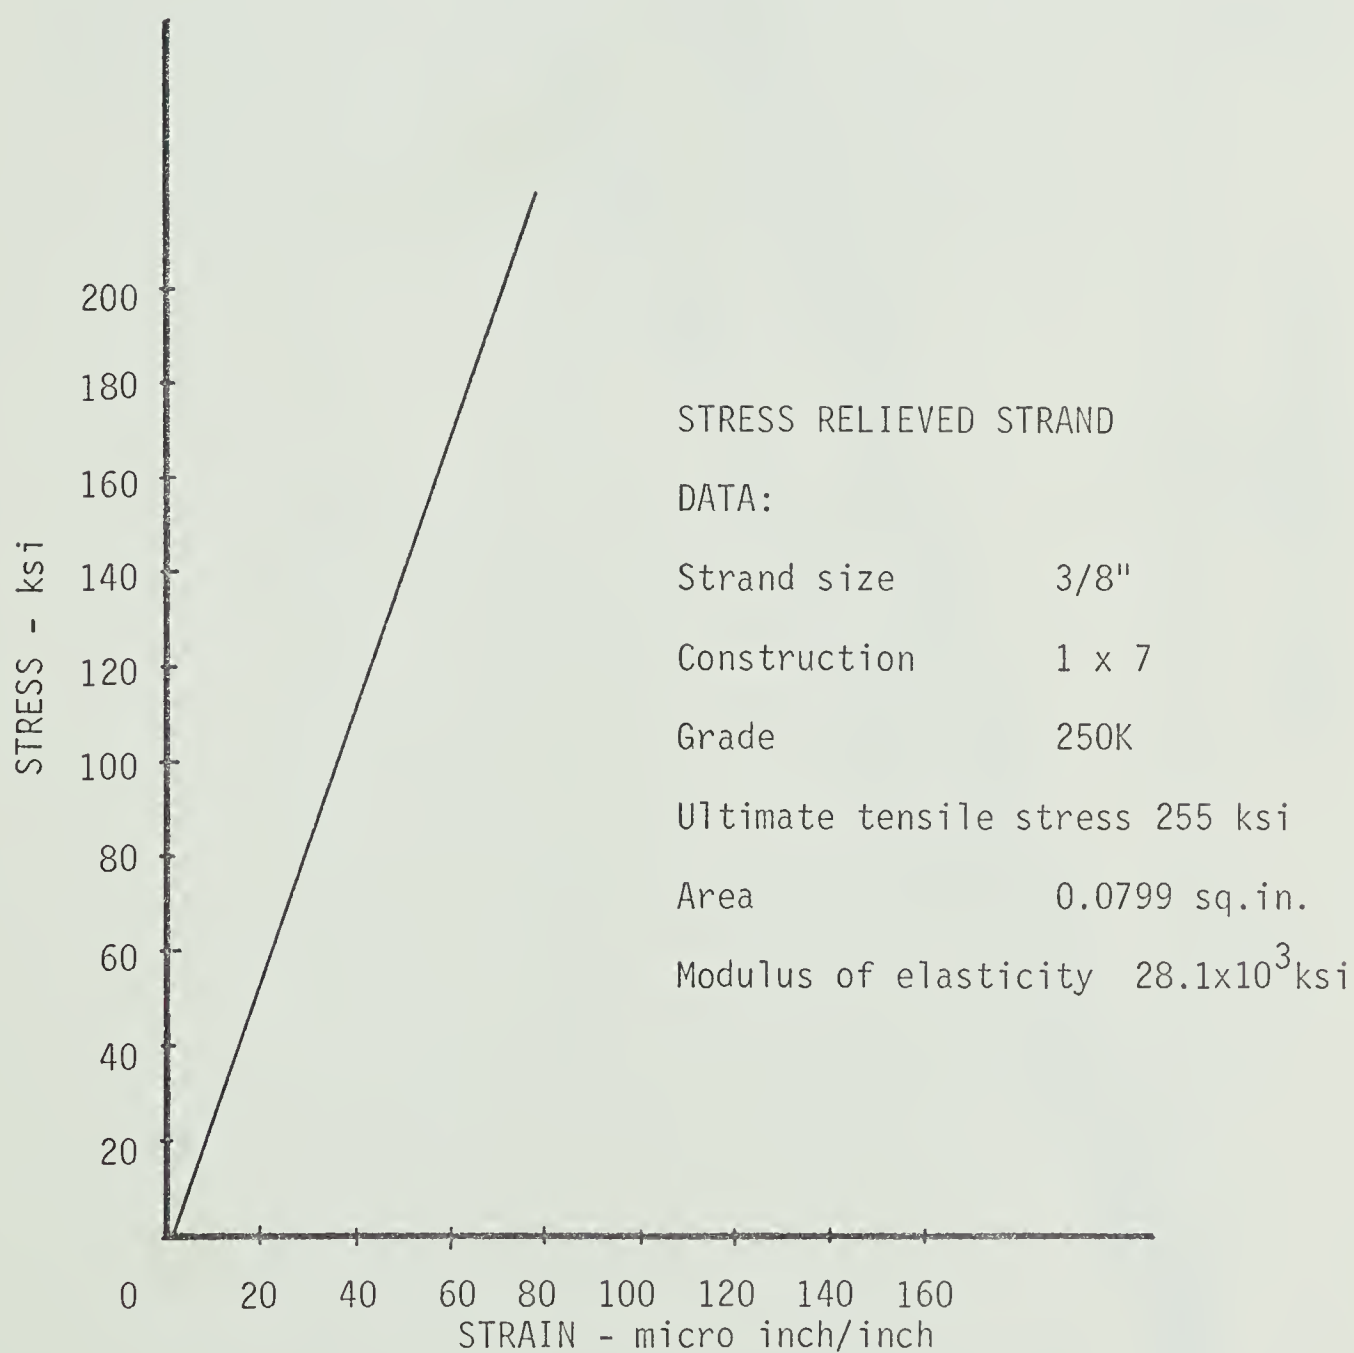
FIGURE A.1 STRESS - STRAIN RELATIONSHIP OF  
PRESTRESSING STRAND

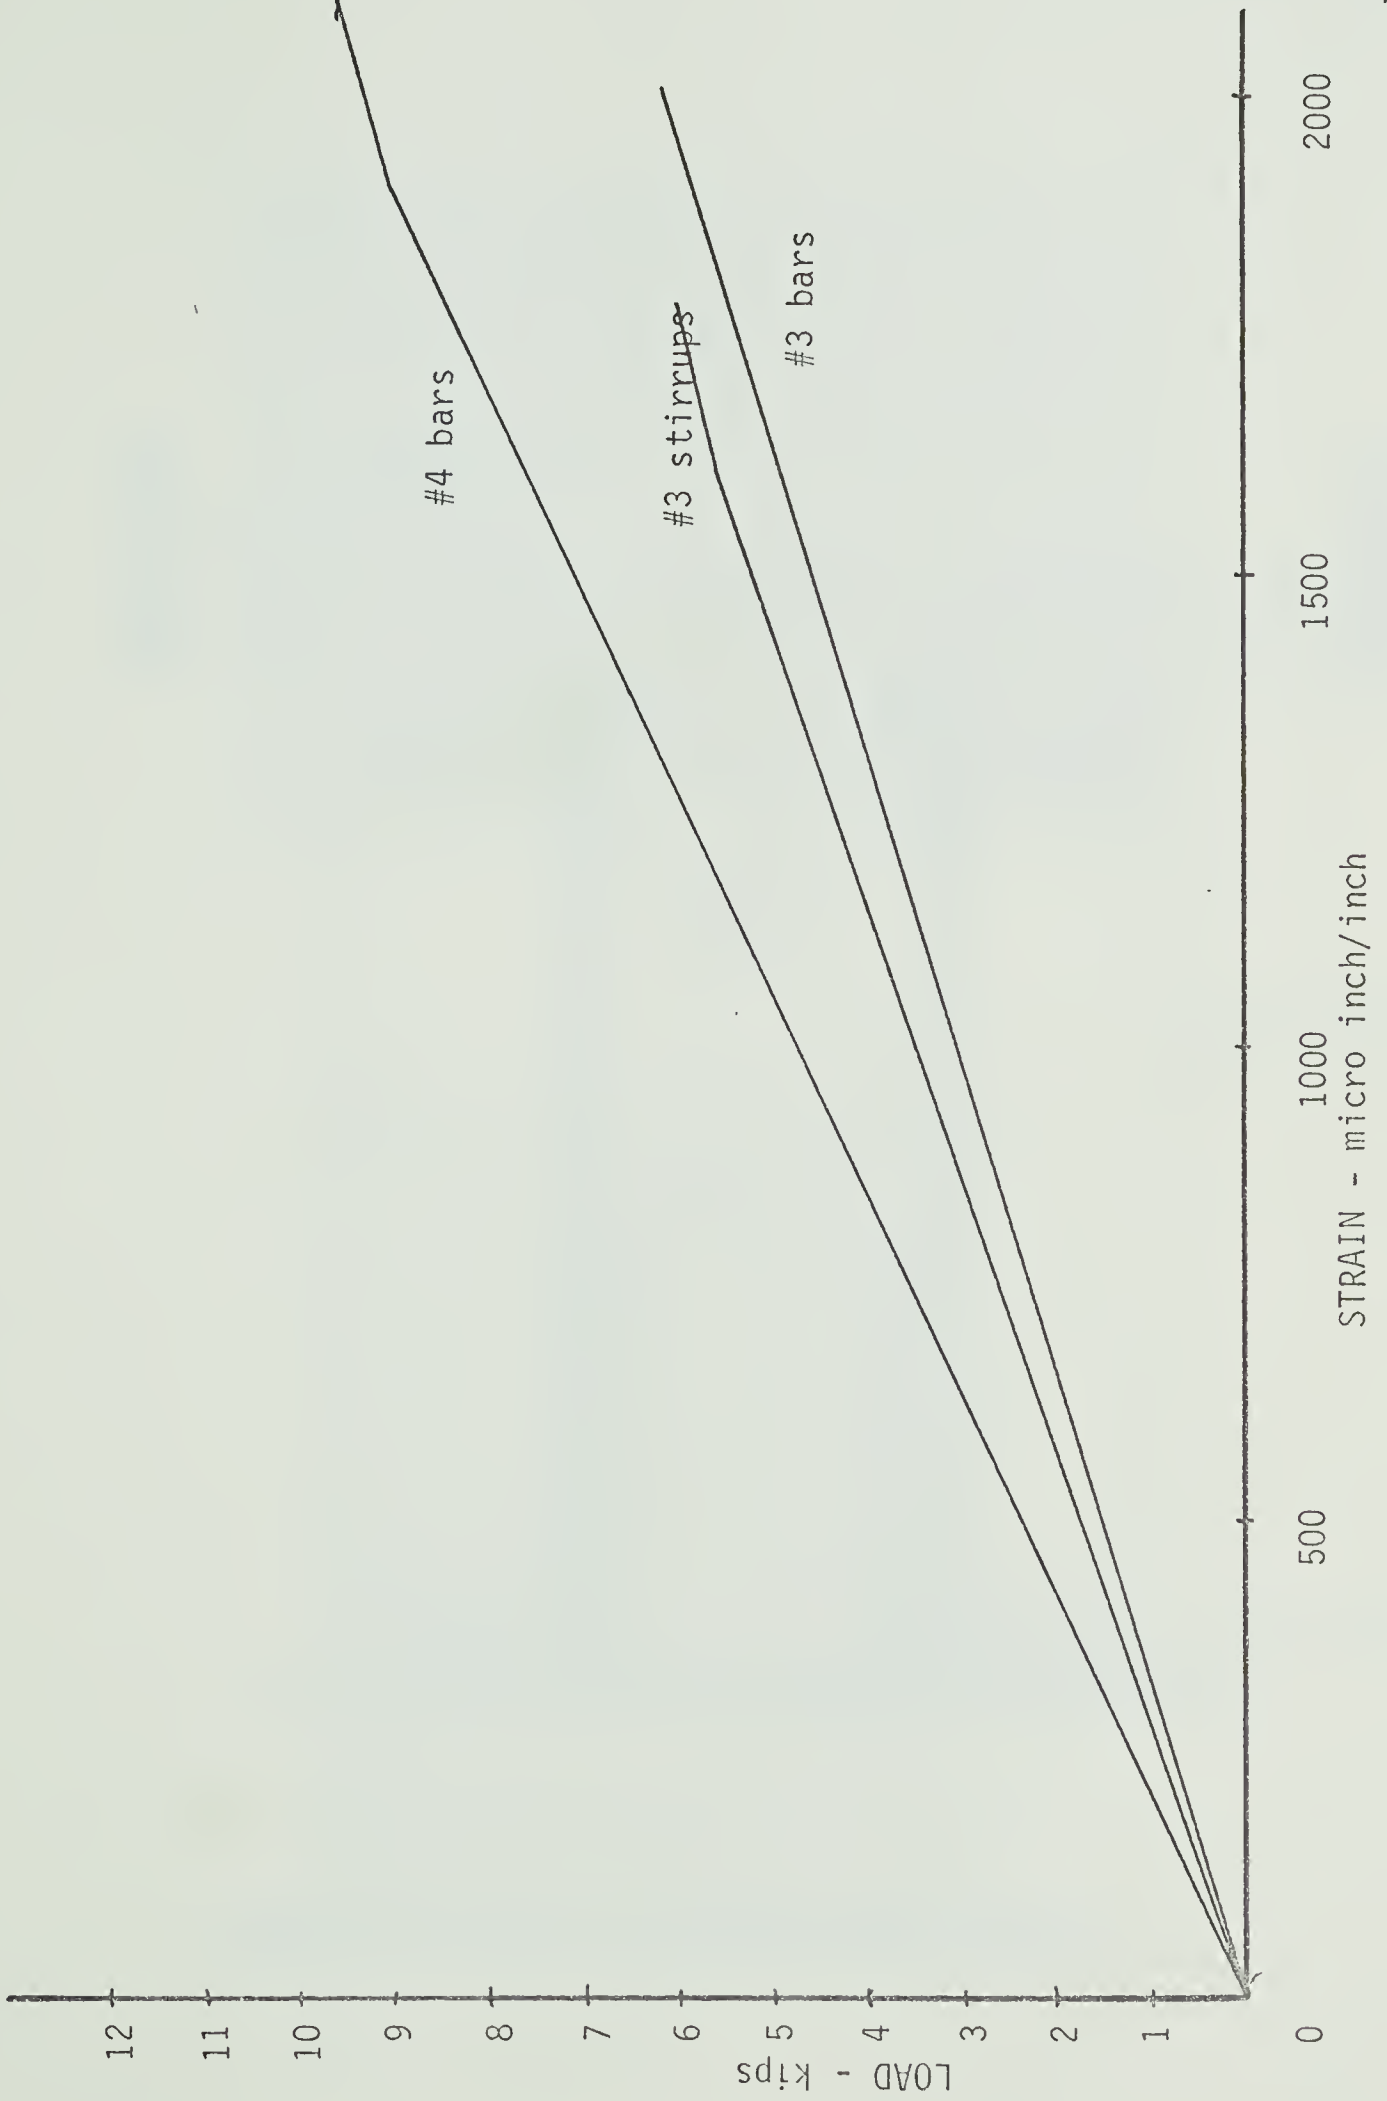
FIGURE A.2 LOAD - STRAIN RELATIONSHIPS FOR VERTICAL AND LONGITUDINAL REINFORCEMENT

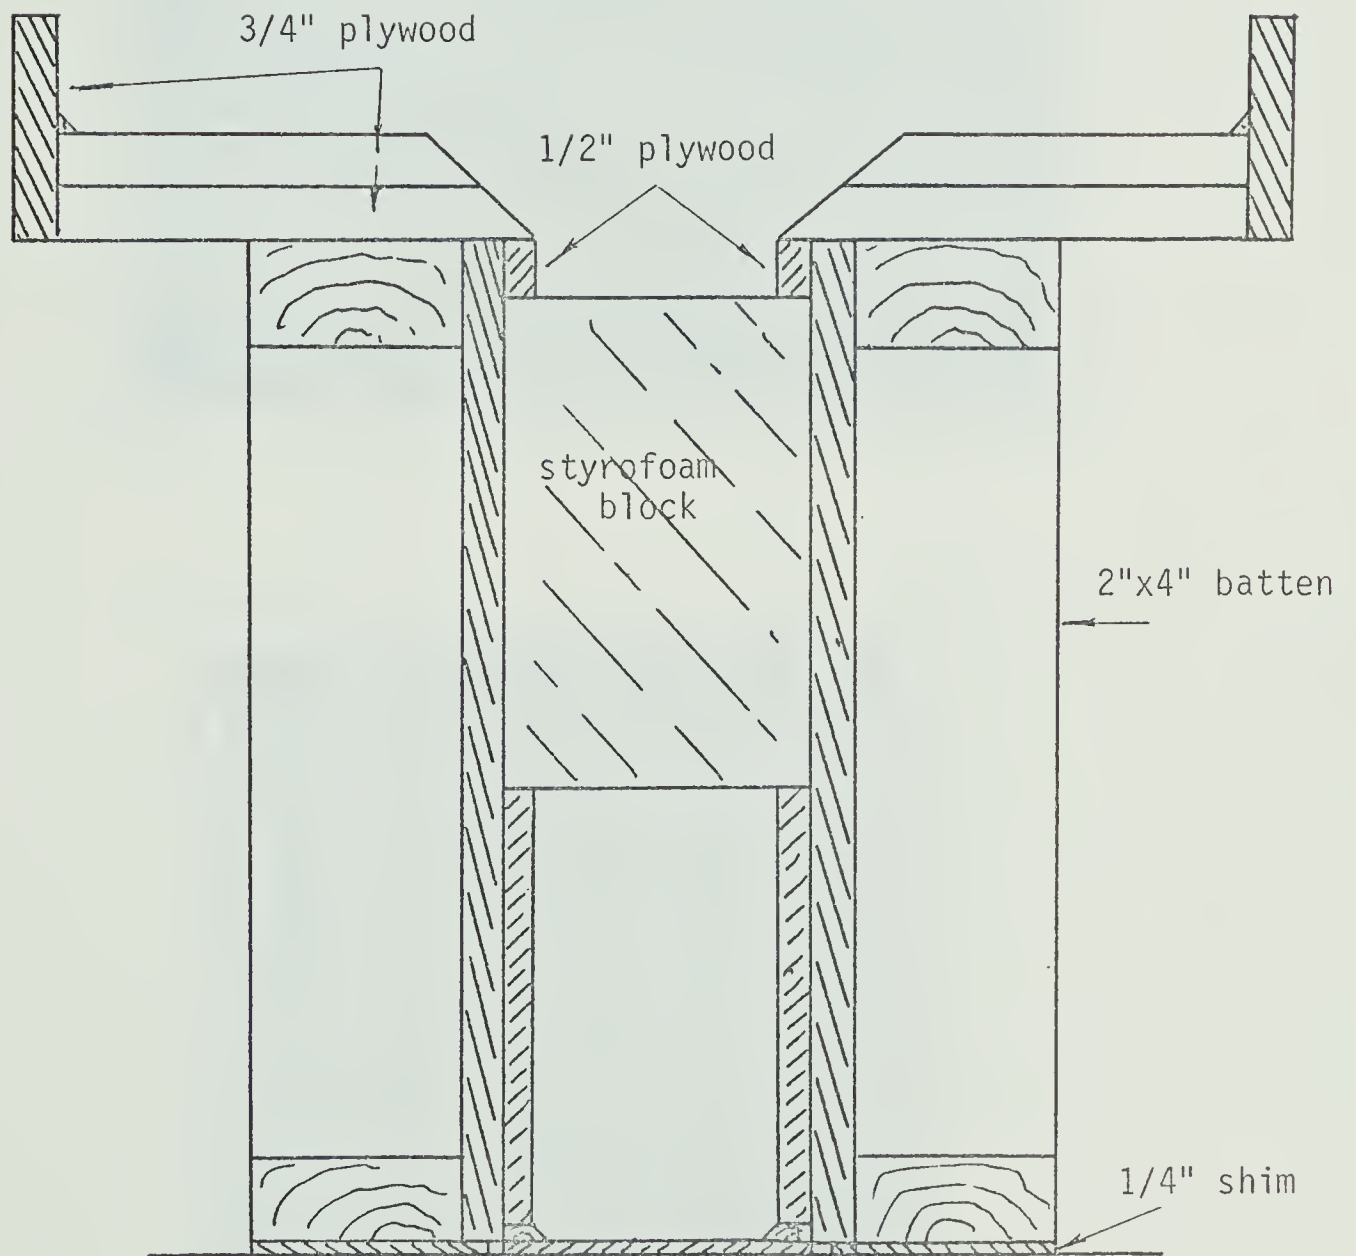
FIGURE A.3 TYPICAL X-SECTION THROUGH FORMWORK

After the concrete had set for 24 hours, the exterior forms were unbolted and slipped off while the interior forms were peeled off the hardened concrete. The styrofoam blocks were then punched through. This method worked extremely well and is recommended for future casting operations.
